**PROJECT REPORT ON THE RESTORATION
OF THE
“THE GOOD SAMARITAN” WINDOW
DESIGNED BY THE TIFFANY STUDIOS IN 1900**

Lafayette Avenue Presbyterian Church

BROOKLYN STAINED GLASS CONSERVATION CENTER

March/August 2004

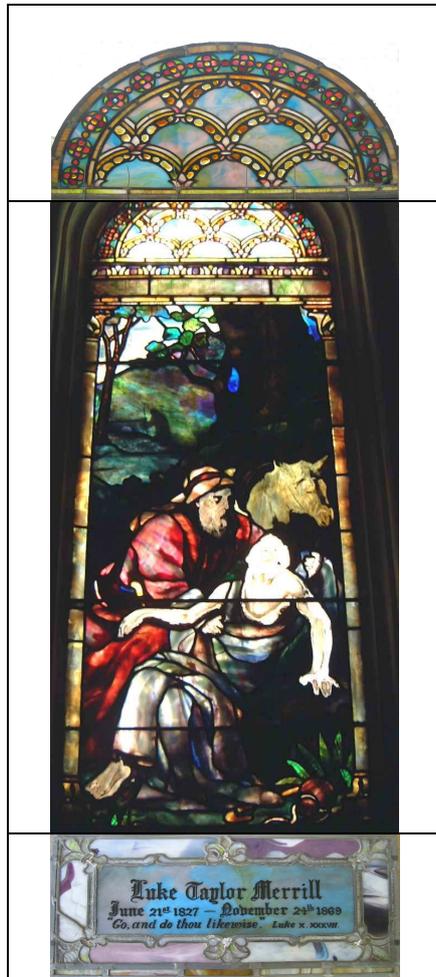
The window is set into a wooden frame. It is further supported by round, steel saddle bars that are set into the wood and attached to the panels by means of copper tie wires. On the exterior of the window, a plate glass was installed.

It is a Roman arch topped and is divided in three sections:

- An upper part of the window is meant to have a decorative effect and is more of a geometric and Byzantine style. Different streaky or rippled opalescent glasses are used in small fragments and are highlighted with cast jewels made of dalle glass (26' wide, 13'7/16 tall);
- A main section consisting of two figures and a donkey in a landscape, made out of a rich palette of opalescent glass, and painted pieces for the flesh. The window depicts an episode from the Bible (Luke X: 37), the Good Samaritan parable (26 wide, 58 ½ tall). The mood of this window is dark and intimate;
- A small, horizontal, center-pivot ventilator section containing a memorial painted plate on top of a semi-opalescent glass. This section has been reduced to fit into a new metallic frame (22 ½ wide, 11'6/8 tall);

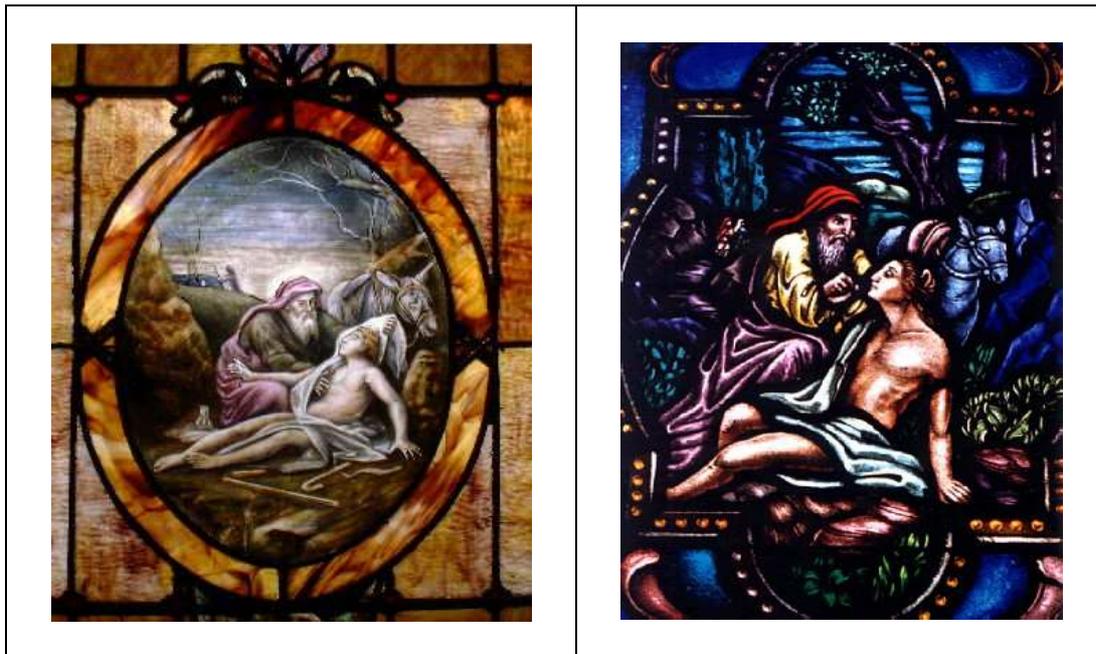
Research in the field of painting are done in several data banks and libraries. The window seems to have been designed from an existing painting; even though we did extensive research, we could not find the original painting. What makes us think that there *is* an existing painting is that we found two other windows designed by other artists.

We also had the incredible luck to find another church, Brown Baptist Memorial Church on Gates Avenue in Brooklyn, a few hundred meters away from the Lafayette Avenue Presbyterian Church, having exactly the same window. It seems to us that the same cartoon has been used. Fortunately, the painted pieces in Brown Baptist Memorial Church are less damaged than the ones in Lafayette Avenue Presbyterian Church. This fact turns out to be a wonderful help in the restoration process for we will have some information on the painted pieces.
